MOHAWK RIVER BASIN
TOWN OF GERMAN FLATTS
HERKIMER COUNTY, NEW YORK

**ILION RESERVOIR
NO. 1 DAM
NY 00186**

PHASE I INSPECTION REPORT
NATIONAL DAM INSPECTION PROGRAM

JULY 1981

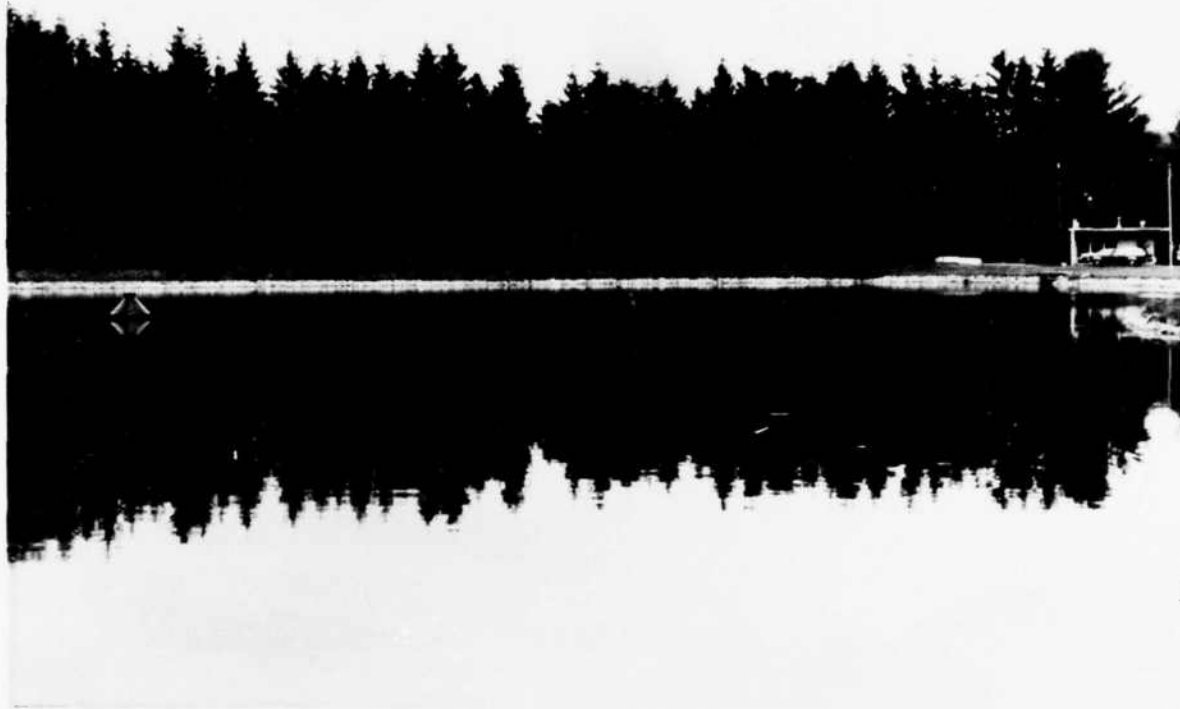
Overview Photo - Ilion Reservoir No. 1 Dam from upstream - 6/4/81

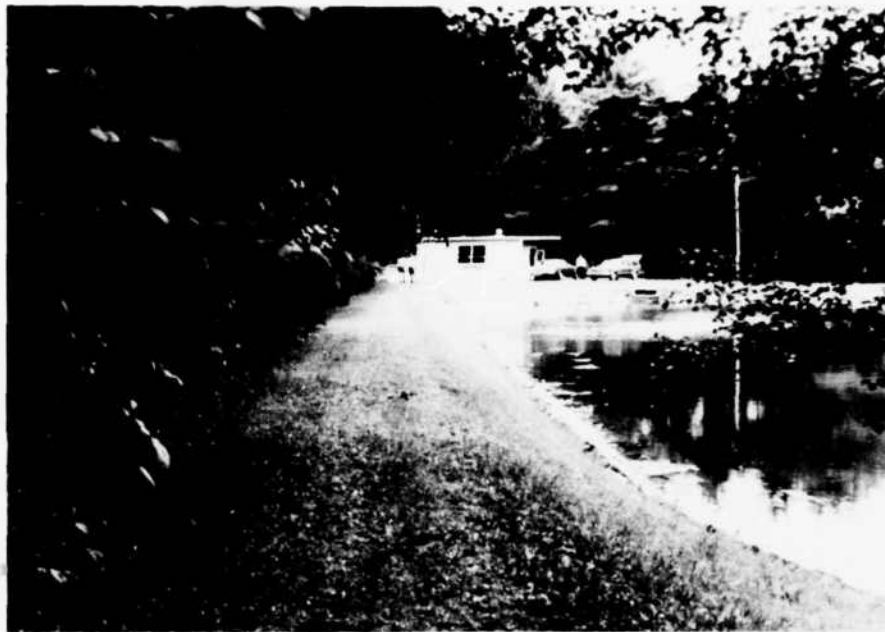
Crest - The crest of the dam is covered with grass which is kept mowed (see Photo A-2A). Many tree roots extend across the top of the crest, from trees on the downstream slope to the upstream side of the crest (see Photo A-2B). The crest appears to be well maintained and shows no signs of settlement, cracking, or horizontal movement.

A-2A Top of dam looking from left abutment - 6/4/81

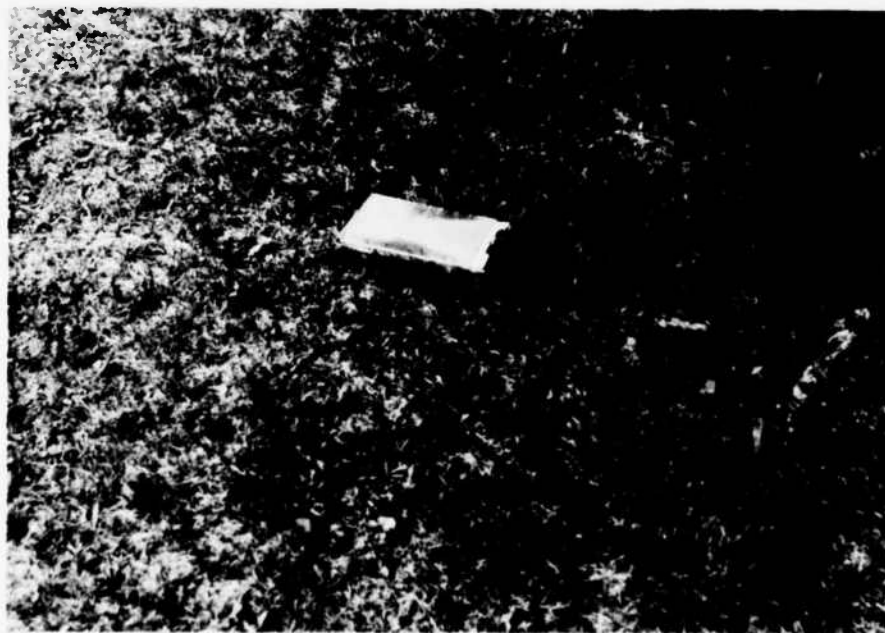
Many large trees growing on the downstream slope and on the left abutment of the dam could lead to seepage problems and internal erosion (piping) of the embankment if any of the trees blow over and pull out their roots or if any of the trees die and their roots rot.

A-2B Tree roots across top of dam at about Sta 2+20. (Many other tree roots across top of dam at other locations) - 6/4/81

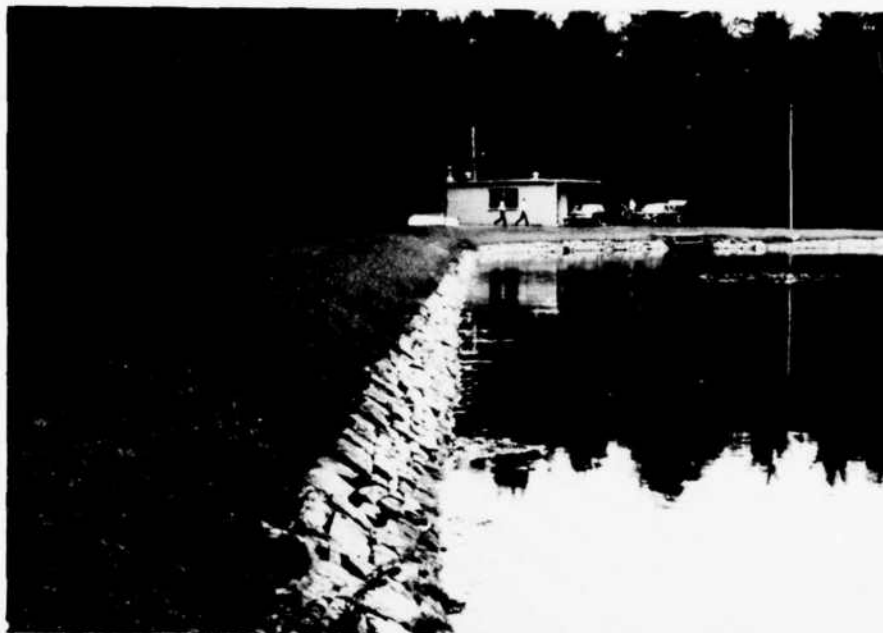
Upstream Slope - The upstream slope of the dam is covered with handplaced riprap up to an elevation about 2 feet above the water surface in the reservoir, and the riprap is in good condition. Above the riprap, the upstream slope is covered with grass which is kept mowed (see Photo A-3A).

A-3A Upstream slope of dam with hand-placed riprap, looking from left abutment. Note microstrainer / treatment plant office building and entrance to spillway in background - 6/4/81

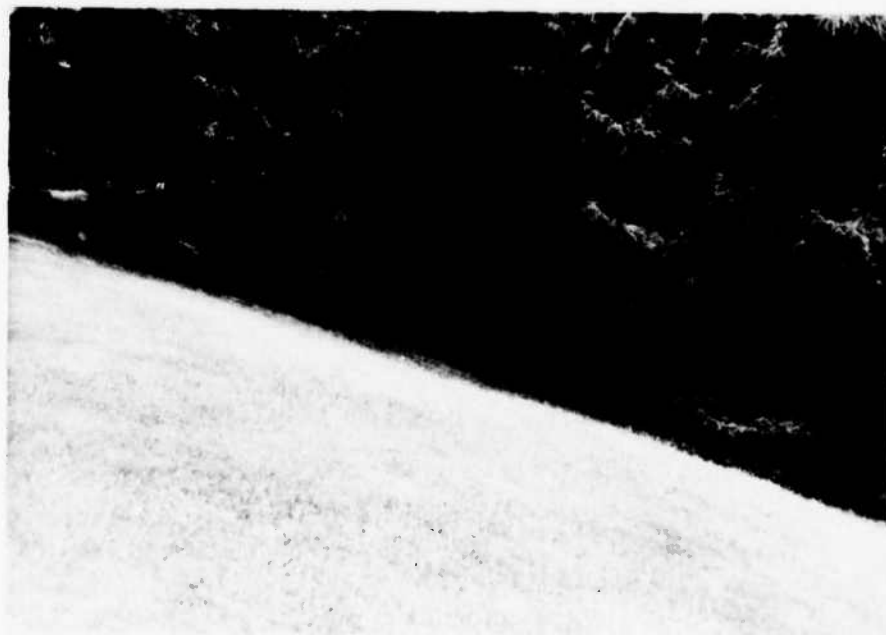
A-3B Contact between downstream slope and right abutment, with trees on slope and grass on abutment - 6/4/81

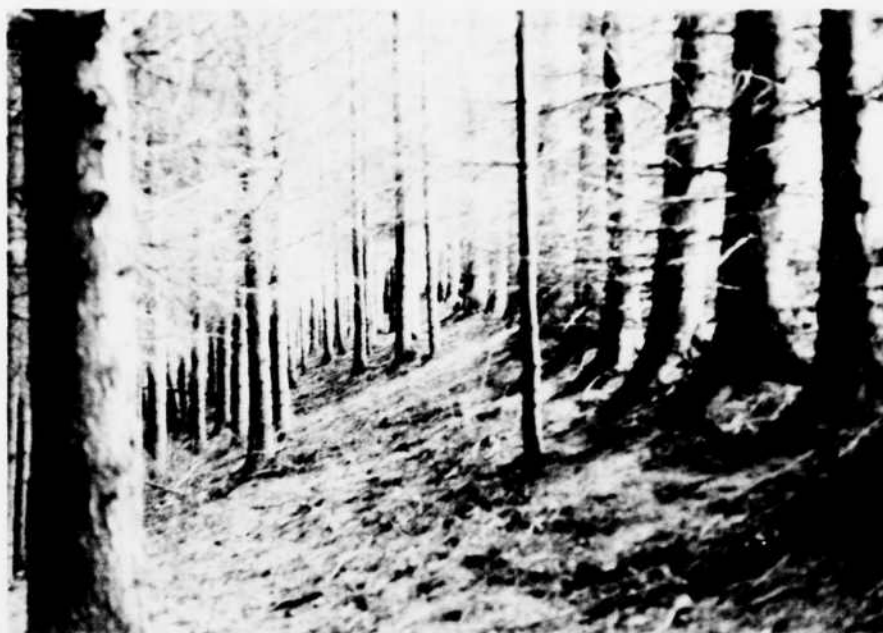
82 The downstream slope of the dam is steeper than that of similar dams designed in accordance with modern standards of practice and should be evaluated to determine whether it has an adequate factor of safety against failure.

A-4A Downstream slope of dam viewed from left abutment - 6/4/81

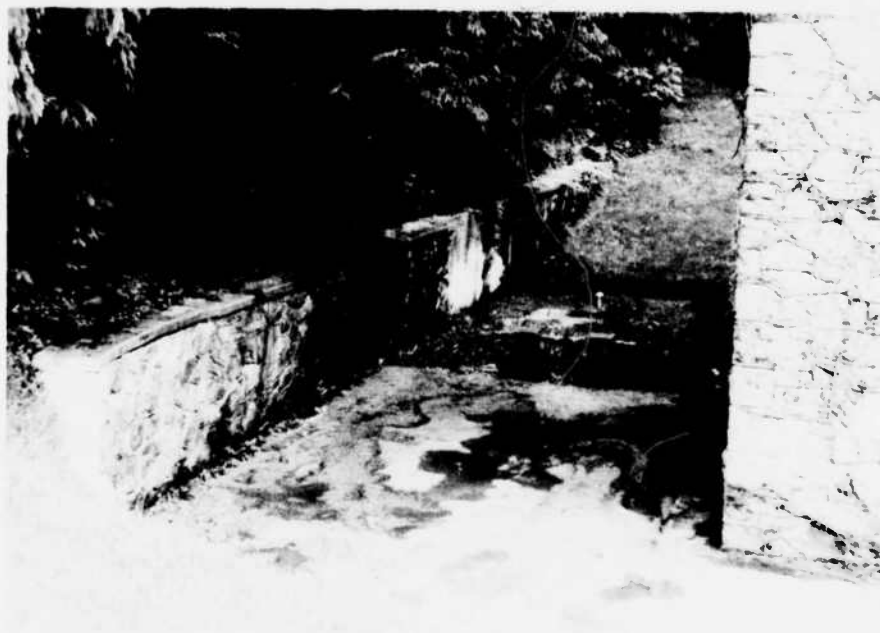
toe of the embankment is retained by a stone masonry and concrete retaining wall, there is a soft, wet area with some standing water next to the base of the retaining wall. This retaining wall is cracked in several places and displaced downstream (see Photo A-4B).

The cracked and displaced retaining wall at the downstream toe of the dam is a cause for concern.

A-4B Stone masonry wall at downstream toe of dam - 6/4/81

- 1) Investigate the seepage at the downstream toe of the dam.
- 2) Investigate the cracked and displaced condition of the retaining wall at the downstream toe of the dam.

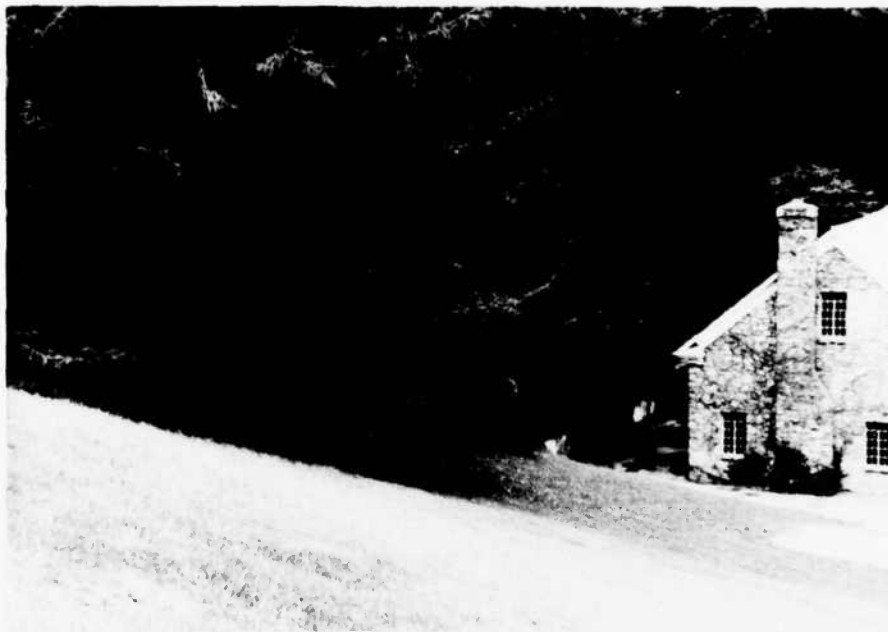
Abutments - Both abutments of the dam appear to consist of soil. No bedrock outcrops were observed in the vicinity of the dam. Trees are growing on the contact between the downstream slope of the dam and the left abutment. Along the contact between the downstream slope and the right abutment, trees are growing on the downstream slope and grass, which is kept mowed, is growing on the abutment itself (see Photo A-5A).

A-5A Downstream slope of dam near toe viewed from above right abutment. Softener building is at middle right of photo - 6/4/81

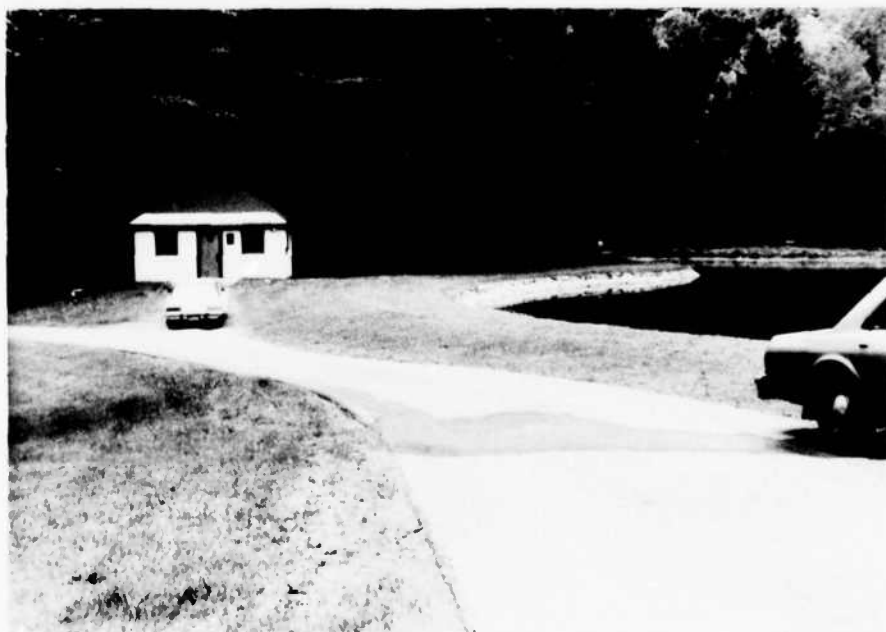
On the south side of the reservoir, near the right abutment of the dam, there is a low dike built across a saddle in the reservoir perimeter (see Photo A-5B). The dike is covered with grass, which is kept mowed, and appears to be in good condition. The upstream slope of the dike is riprapped up to an elevation about 2 feet above the level of water in the reservoir.

A-5B Downstream side of dike - 6/4/81

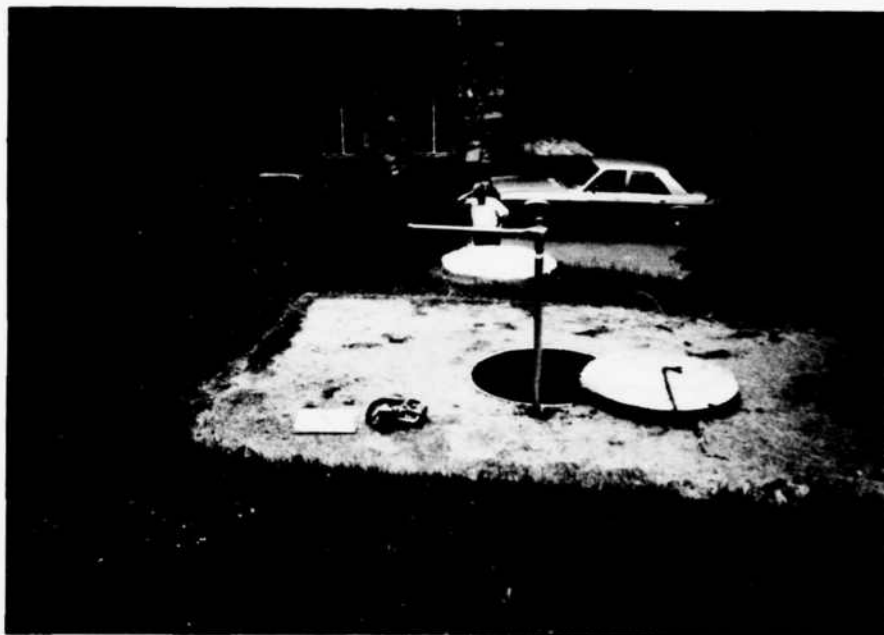
A-6A Vault for downstream valve on outlet pipe - 6/4/81

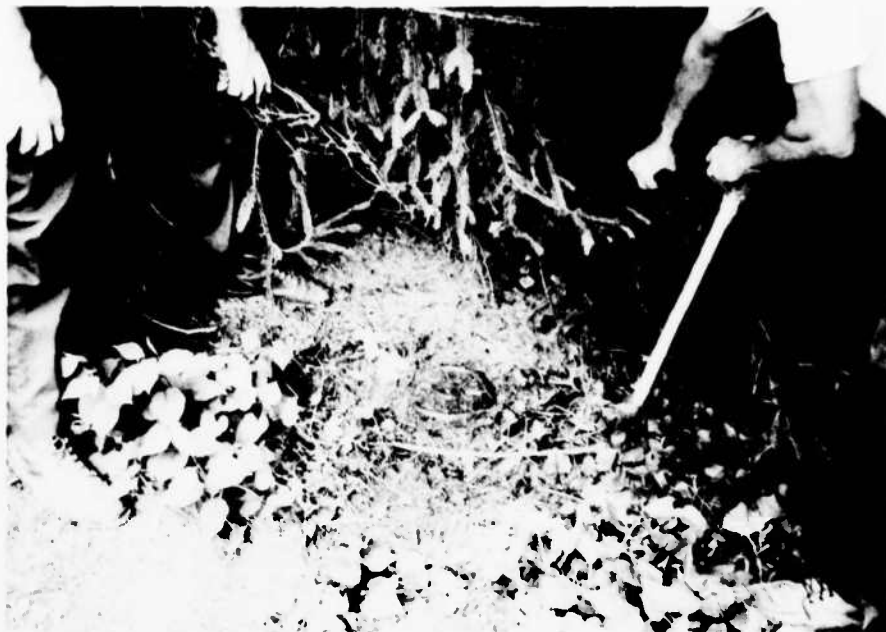
A-7A Valve box on downstream slope of dam for upstream valve on outlet pipe - 6/4/81

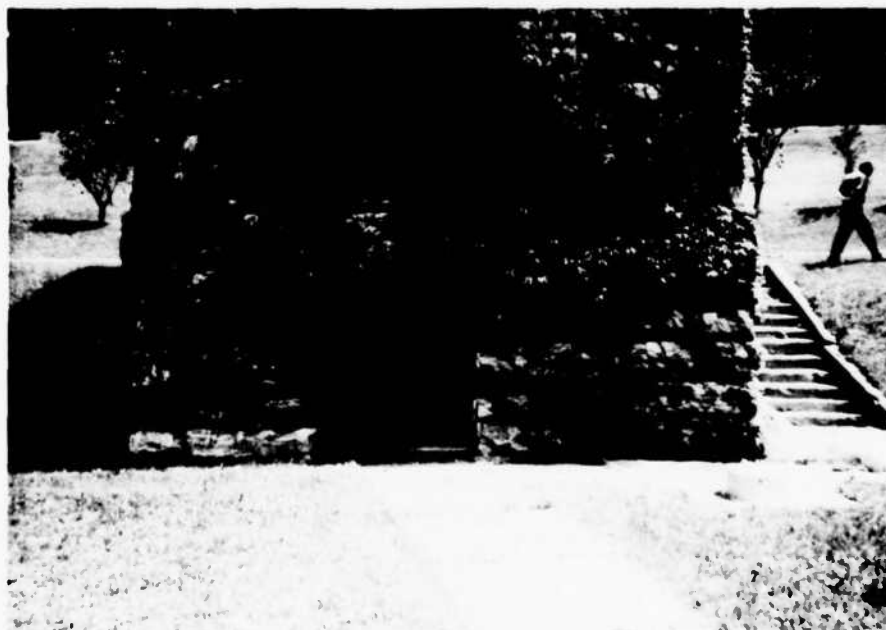
Only the downstream end of the blowoff and the valve on the blowoff, both located in the lower level of the filter plant control building (see Photo A-7B), were observable. The building is in good condition, with some sediment deposited in the bottom due to the operation of the blowoff. The handwheel on the valve is located

A-7B Filter plant control building. Doorway is entrance to ladder to lower level. End of blowoff and blowoff valve located on bottom level and handwheel for valve located on top level - 6/4/81

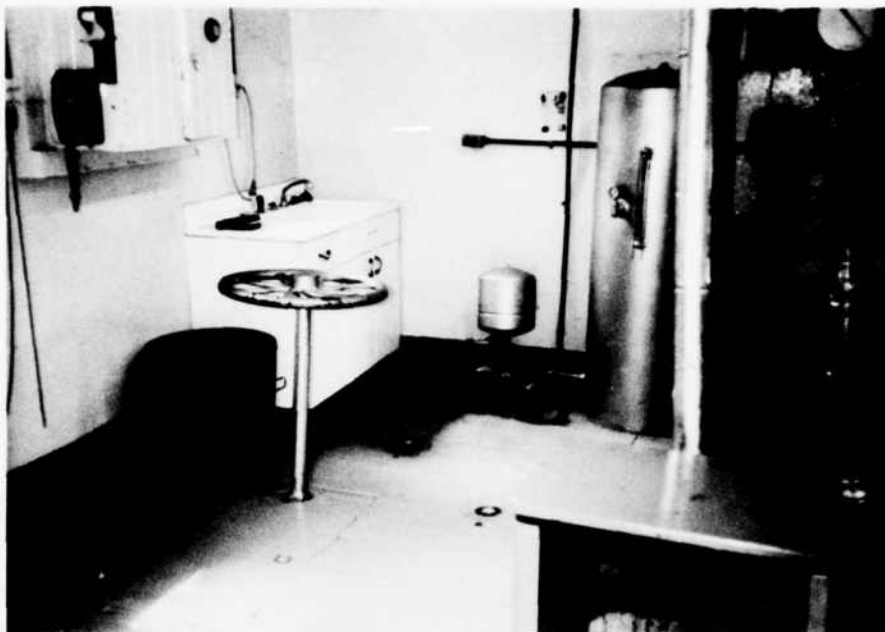
A-8A Top level of filter plant control building with removable handwheel and stem on blowoff valve operating nut - 6/4/81

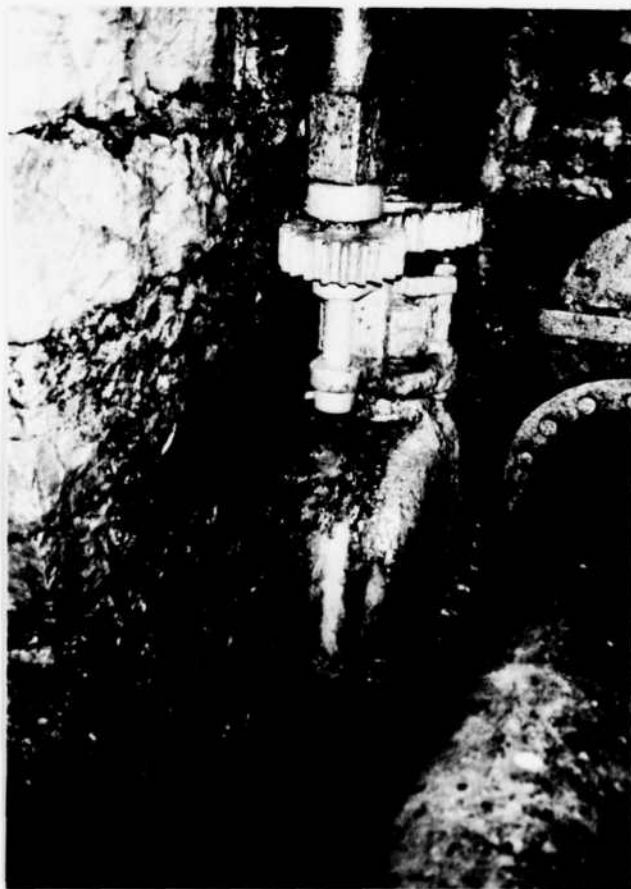
81 on the top floor of the filter plant control building, is used regularly, and is in good condition (see Photo A-8A). The valve and downstream end of the pipe are rusted but still function adequately (see Photos A-8B and A-9A).

A-8B Blowoff valve in bottom of filter plant control building - 6/4/81

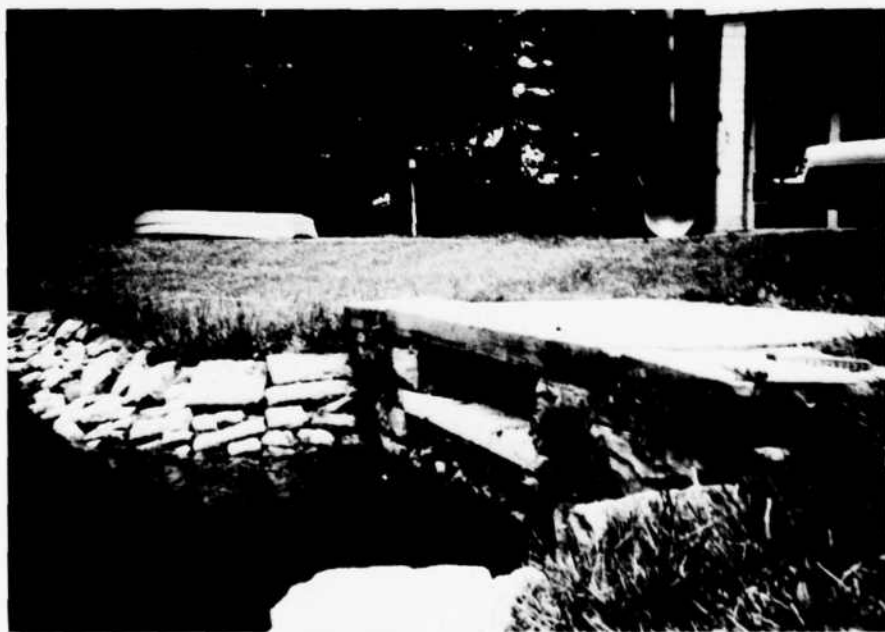
The only parts of the spillway observable were the upstream wall of the stone masonry and concrete vault with the overflow opening (see Photo A-9B) and the downstream stone masonry spillway outlet structure (see Photo A-10A). The culvert between these structures was not observable. The upstream vault wall is eroding at the waterline and there is leakage into the vault through the stone masonry. The spillway outlet structure is falling apart. The stone masonry is displaced and many joints are loose.

A-9B Upstream end of spillway - 6/4/81

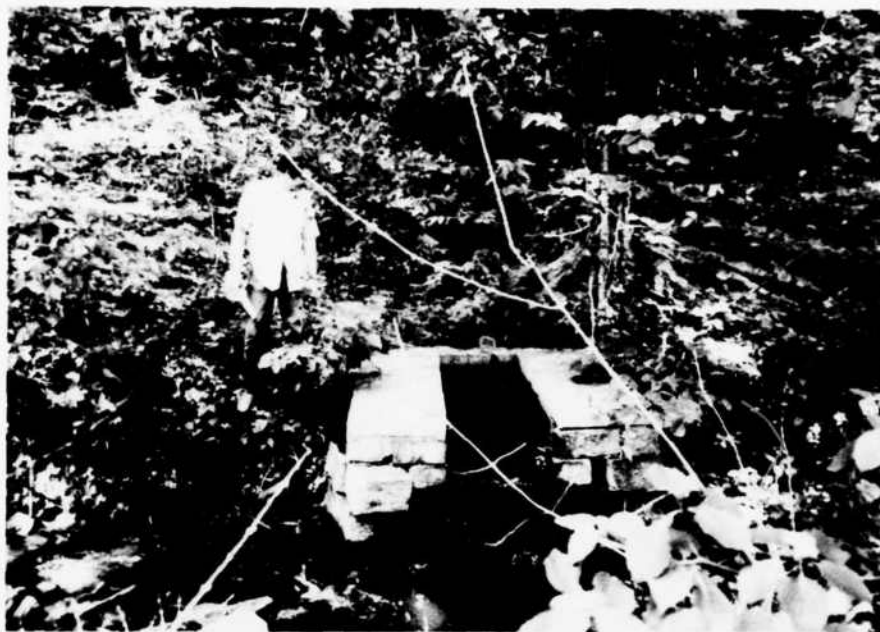
The deteriorated spillway outlet structure could collapse and restrict spillway discharge flows. Also, the deterioration of some of the stone masonry on the spillway structure itself could, in time, seriously weaken the structure if allowed to continue.

A-10A Outlet structure at downstream end of pipe from spillway ~ 6/4/81

- 1) Institute a program to visually inspect - not just casually look at - the dam and its appurtenances at least once a month.
- 2) Repair the deteriorated spillway outlet structure and repair the lesser deterioration of some of the stone masonry on the spillway structure itself.
